**SAS Superstructure**

Daily Diary Report by Bid Item

Contract No.: 04-0120F4

04-0120F4
04-SF-80-13.2/13.9
Self-Anchored
Suspension Bridge

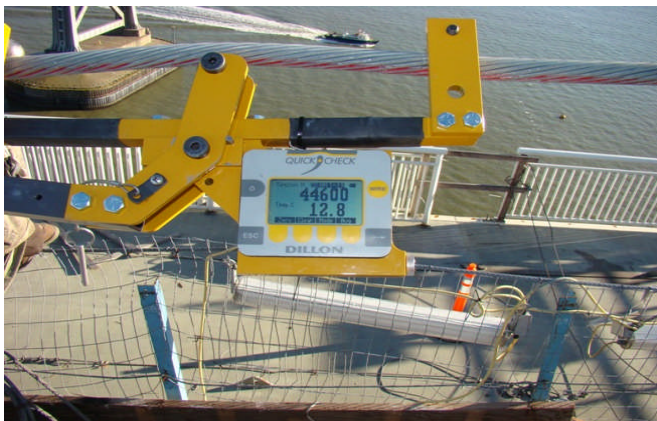
Handrope - Side	// Anchorage at EPP104 //		Average Tension	% of Design (45000kN)
	Main	Anchorage		
Inboard	44100	44900	44500	98.9
Outboard	45600	45400	45500	101.1

Reading on the tension gauge almost near the final tension reading on the outboard South Mainspan handrope cable.

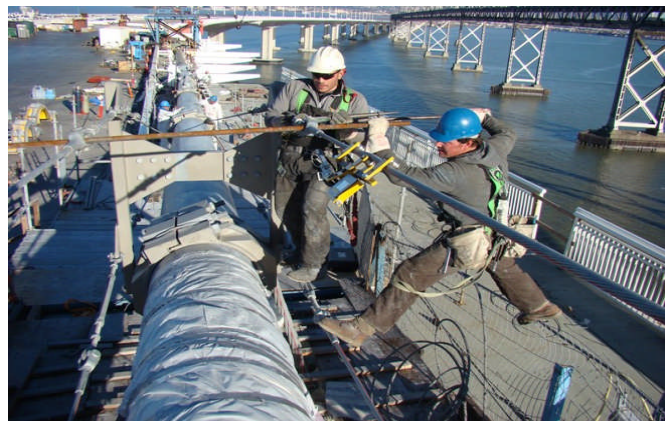
ABF ironworkers tightening the South Mainspan outboard turnbuckle to achieve a tension of 45,000kN in the handrope cable.

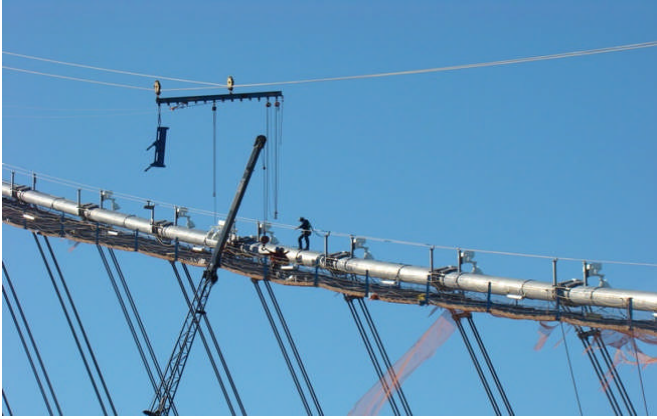
ABF ironworkers installing electrical pullboxes (post type) on the North Mainspan with the assistance of the Grove crane.
